Worldwide repairs carried out with PolymerMetal[®]

REP-# 084

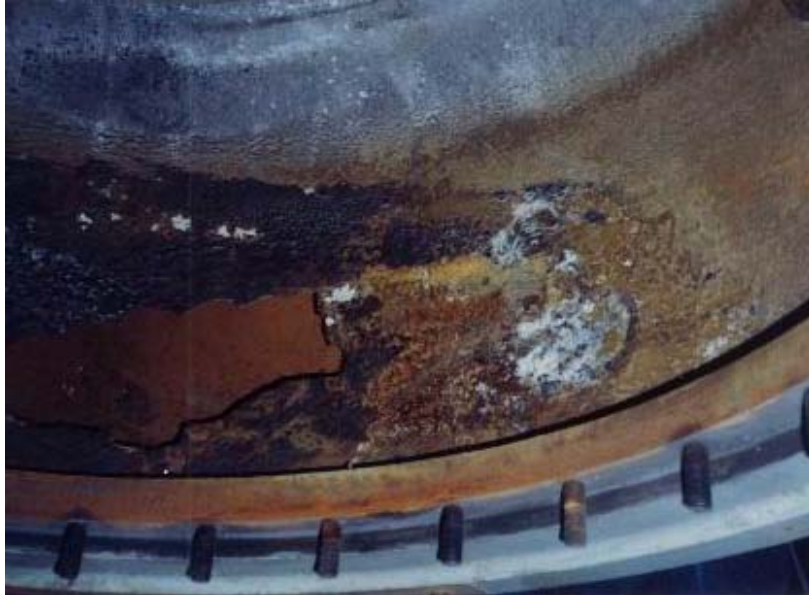
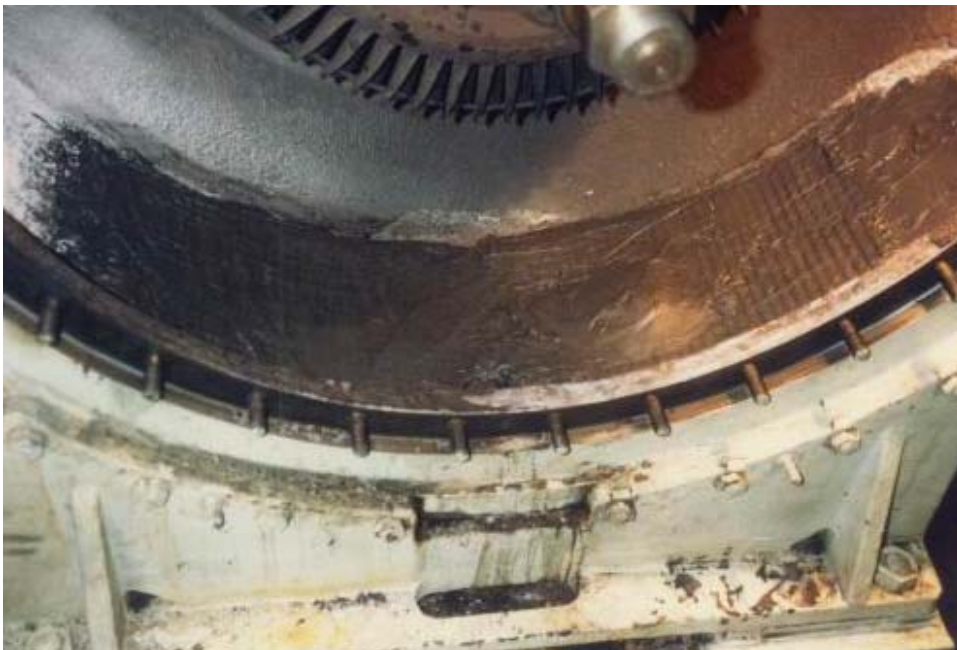
Repair of a turbo charger on board of a ship: during a voyage problems occurred at a turbo charger. The turbine inlet casing was removed and after cleaning a wasted area of appr. 600 mm x 130 mm on the lower part of the casing was revealed. Due to the technical possibilities on board the repair was carried out with MM-metal SS-steelceramic and a steel plate as a reinforcement. At an exhaust temperature of appr. 400 °C in this repair area today MultiMetall's VP 10-500 would have been the better choice.
