MM-Info „Industry“

Info folder with branch specific information of chosen PolymerMetals
for customers from the industry sector

MultiMetall
the MetalExistenceCompany®

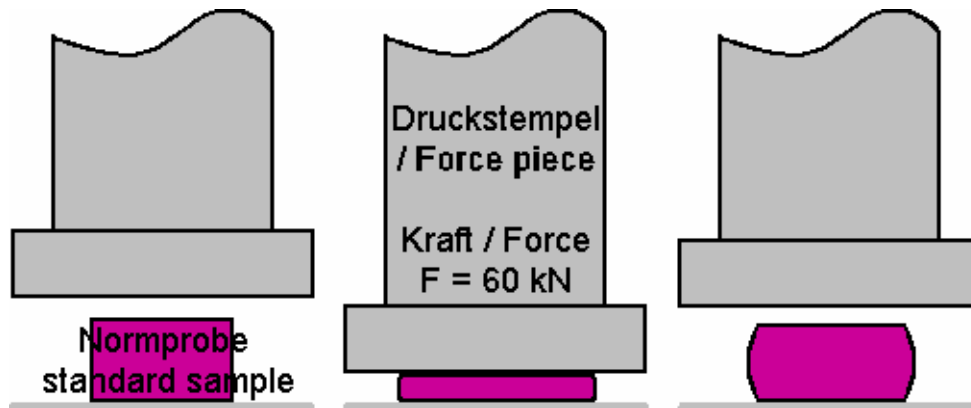
Description

As you can learn from this test, MM-Elastomer disposes high impact strength, hardness and low distortion rest despite of this high use. Furthermore no cracks or excavations could be found after the test. MM-Elastomer is especially suitable for the production of shock and vibration absorbers, cyclone coatings and for the repair of pumps, containers, seals and conveyor belts.

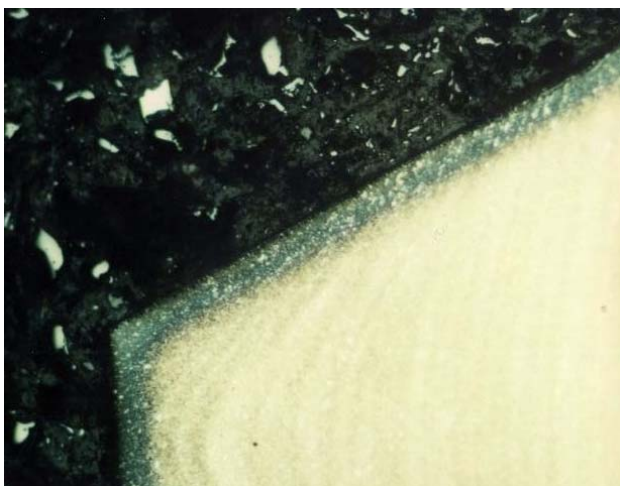
The following pictures show microscopic photographs of the fully cured PolymerMetal MM-metal oL-steelceramic magnified by a factor of 100 and 500. Here the bonding between MM-metal oL-steelceramic and metallic surfaces (steel or casting), which have been contaminated by various applied oils before, has been analyzed.

on industry gear oil / steel
(Magnification 100)

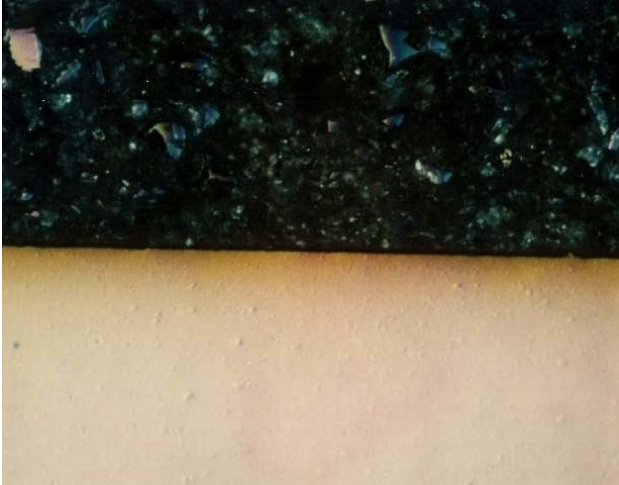
on diesel / steel
(Magnification 100)

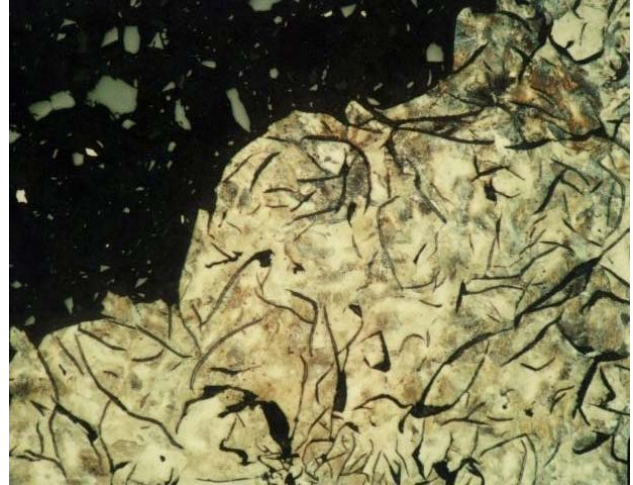
on compression oil KSL 68 / casting
(Magnification 100)

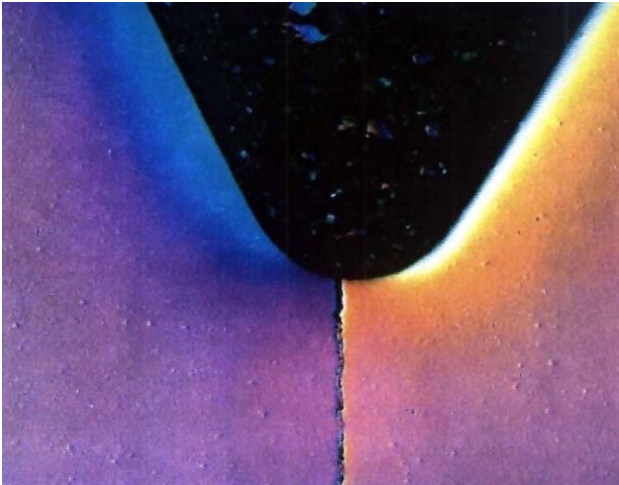
on hydraulic oil T 29-50 / steel
(Magnification 100)

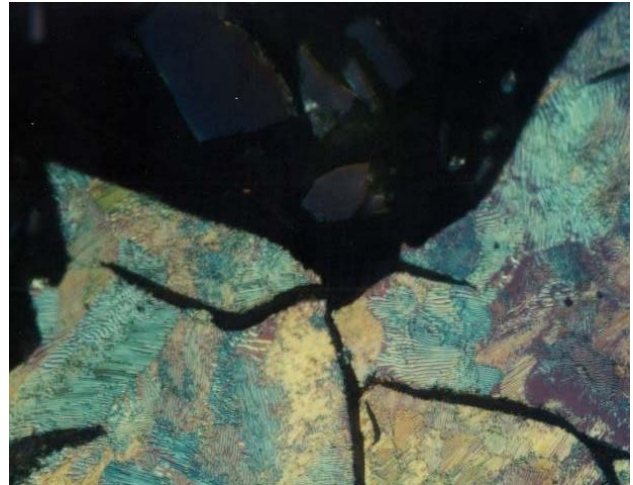
on gear oil / machine oil 55
(Magnification 500)

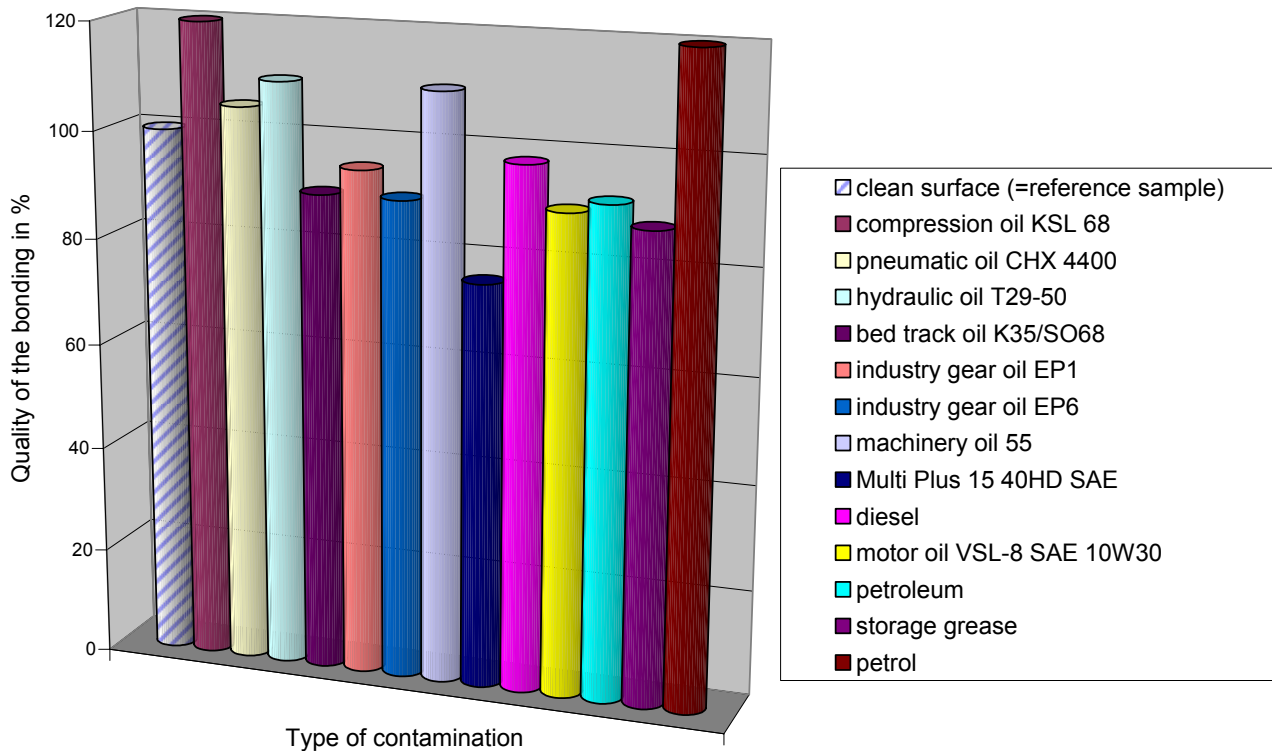
Bonding on oily surfaces

Tests have been carried out to evaluate the quality of the bonding on different surfaces. At the reference test MM-metal oL-steelceramic and Hardener yellow have been applied to a cleaned (that means oil free) and roughened metal surface. The reference value of 100% stands for the quality of the various determined technical data during bending, shearing & hydraulic tests after total curing time. Other values have been determined by applying MM-metal oL-steelceramic on different contaminated metal surfaces. The test results demonstrate that sometimes better technical values were reached after application on oily metal surfaces than on clean metal surfaces.

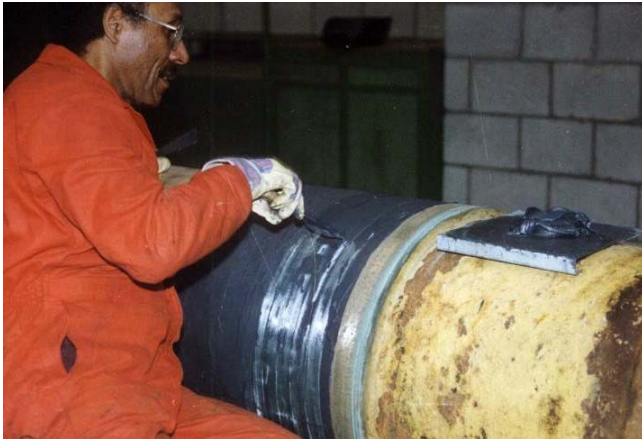
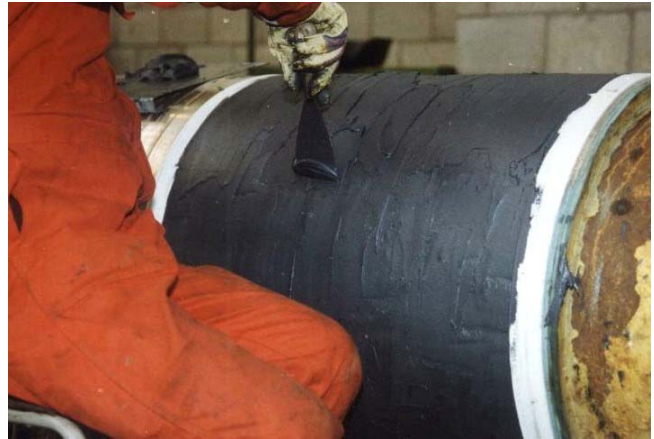
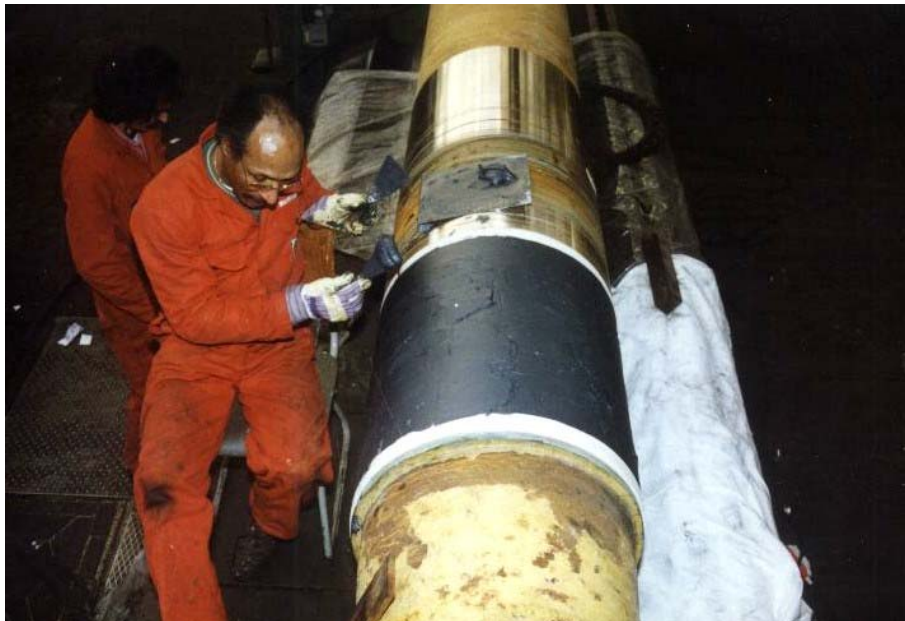
REP-# 093

Repair of a ship propeller shaft made of bronze in the zone of the stuffing box packing with Ceranium paste and Hardener CE. The original shaft diameter of 630 mm was machined down to 615 mm over a length of 60 cm. After the application of Ceranium the diameter was 632 mm. Finally the applied Ceranium was turned down to the requested diameter. For the complete repair 39 units of Ceranium / Hardener CE were used for applying 4 layers. Additionally 3 layers of glass fibre fabric tape were processed.

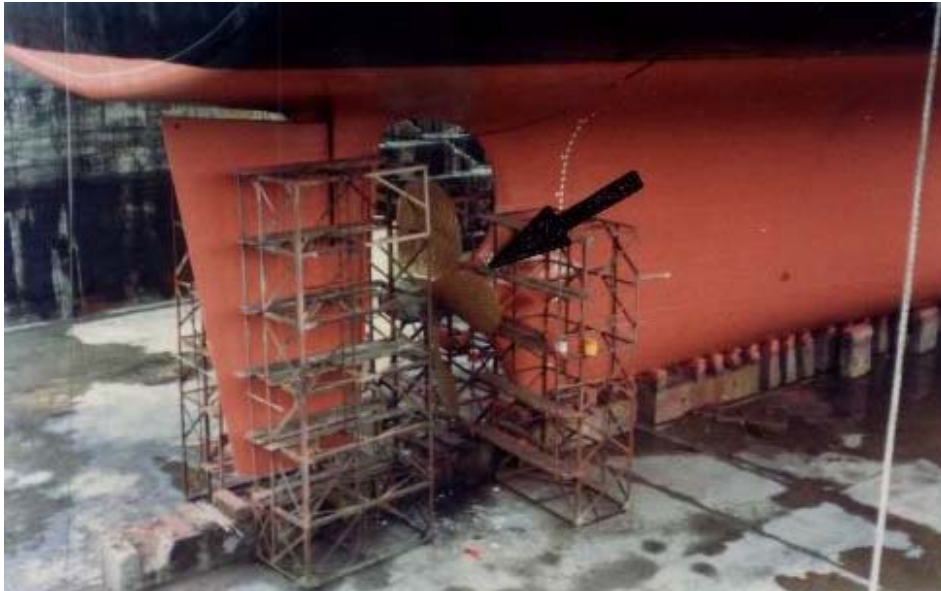
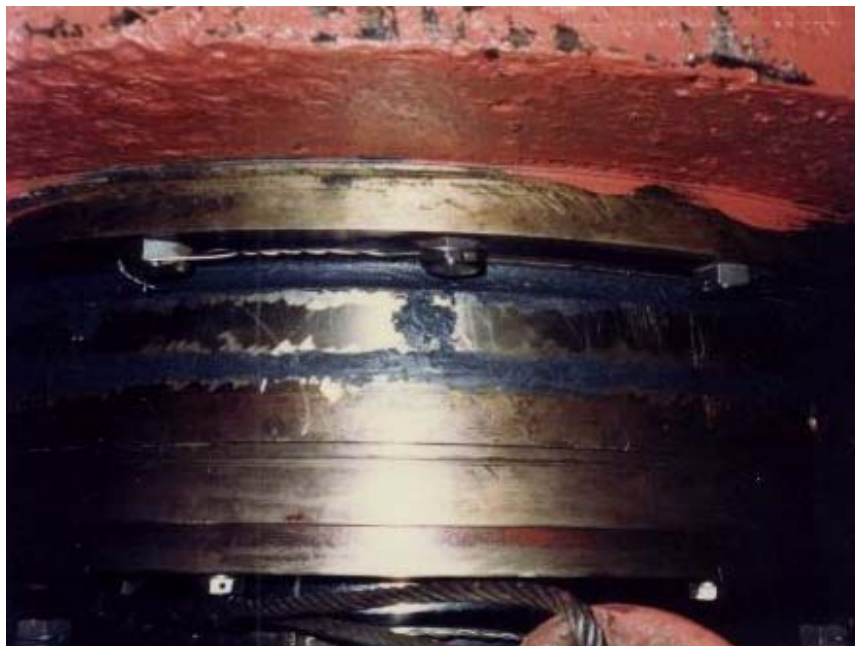
REP-# 115

Repair of a leaking simplex compact packing. The repair was difficult due to oil pouring out of the repair site. Therefore it was decided to use the Direct-MM-Bonding method by applying the PolymerMetal directly on the greasy surface. Here MM-metal oL-steelceramic with Hardener red was chosen.

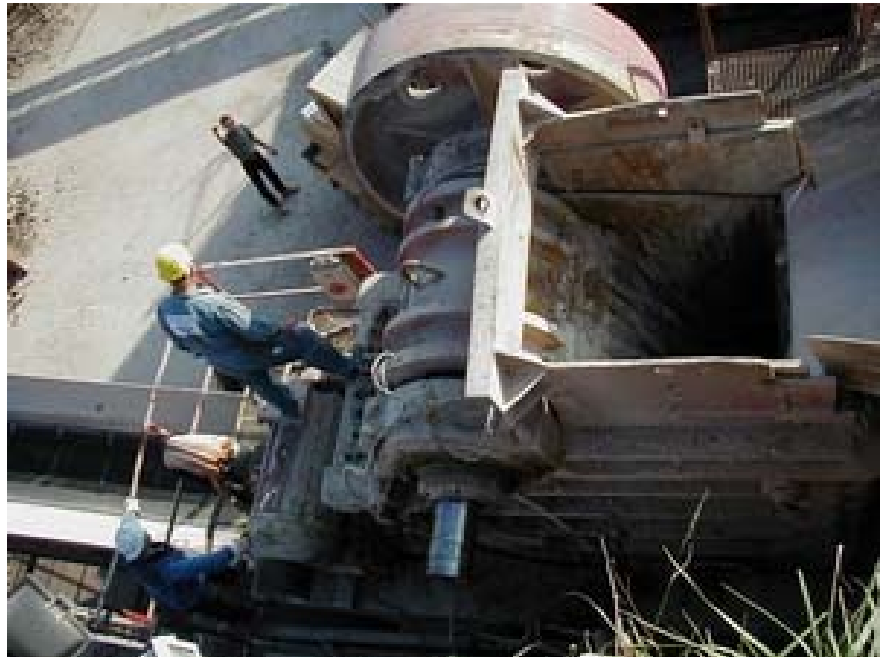
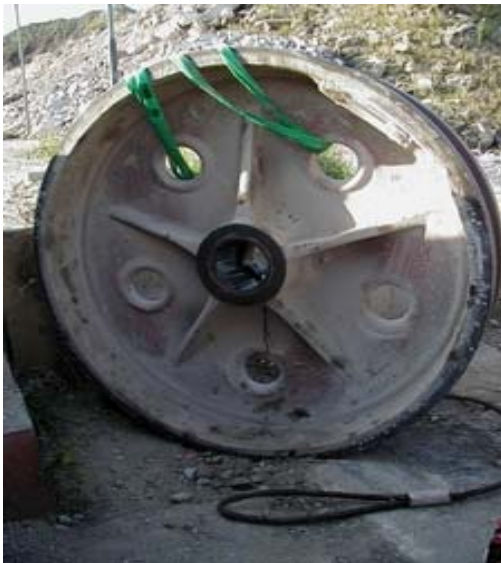
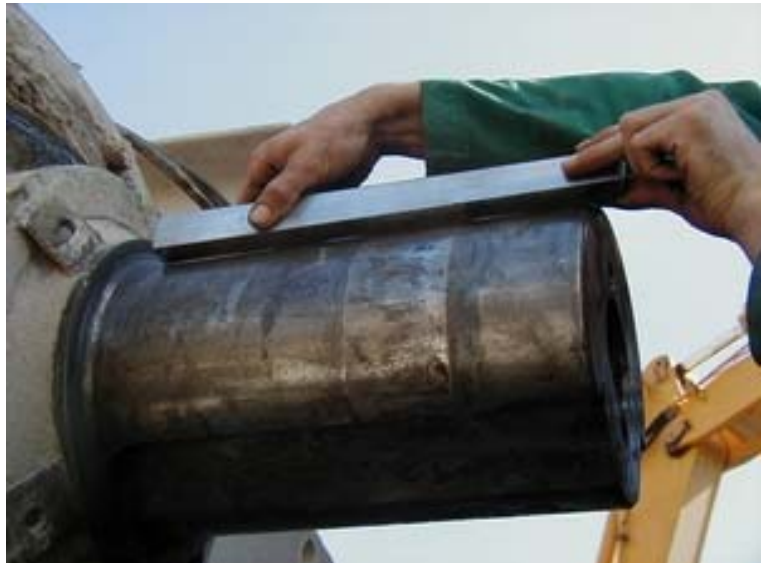
REP-#139

After many years of working, the worn-out rock shaft of a crushing plant for recycling demolition material was repaired with MM-metal SS-steel 382 in September 2002. First the driving fly wheel was carefully dismantled to receive access to the shaft. After the surface preparation of the up to 1 mm worn-out shaft area, MM-metal SS-steel 382 was applied and then machined down to the desired diameter. A replacement due to the necessary dismantling of the damaged shaft, the purchase and the assembly of a new shaft, would have involved considerable additional costs and time. An examination 4,5 years later (March 2007) has come to the result, that the repaired work piece is still in function without any complaints.

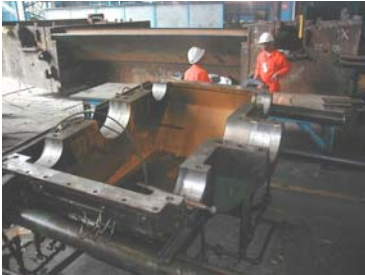
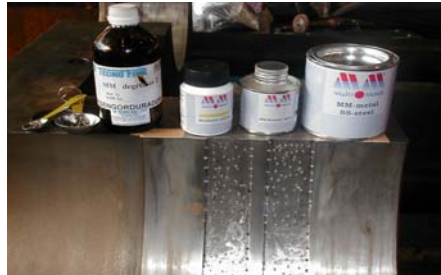
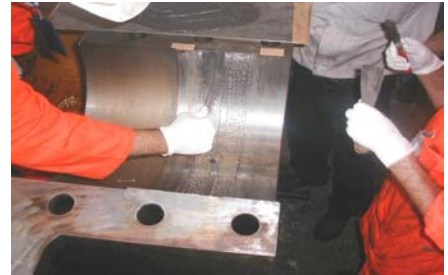
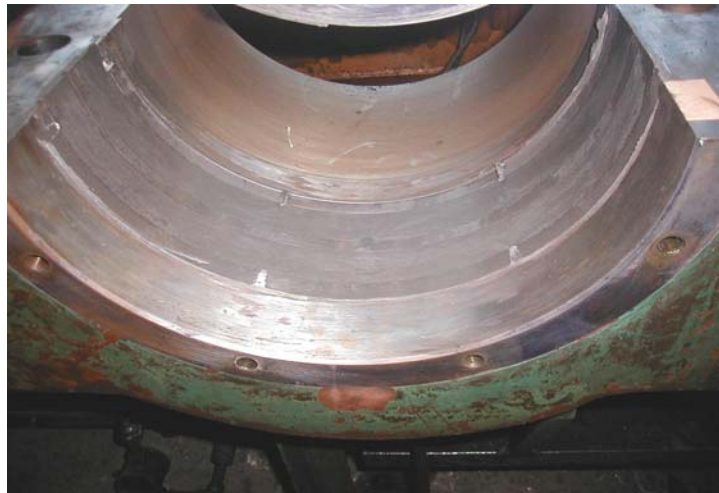
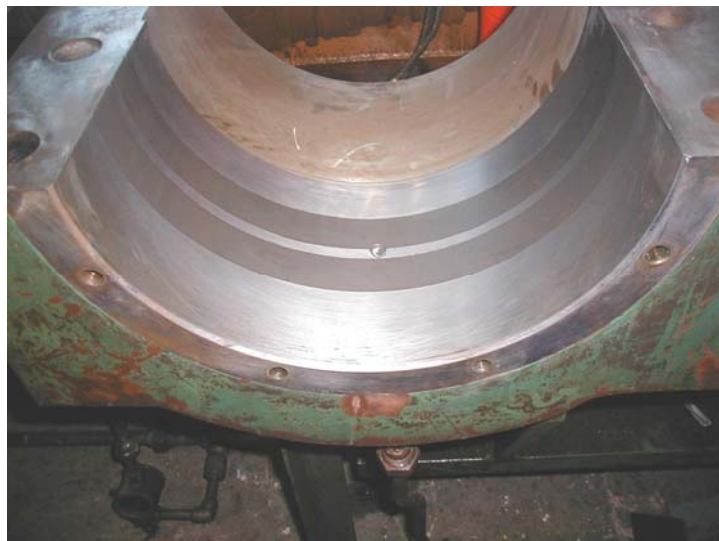
REP-#140

In a steel plant the repair of a broken spool reducer with a weight of 40 t would have taken up 10 days by using the conventional way of welding. By using the repair technology of MultiMetall combined with the PolymerMetal MM-metal SS-steel and MM-Release agent a repair time of just 27 hours was necessary. At the spool reducer a stress of 120 MPa occurs.

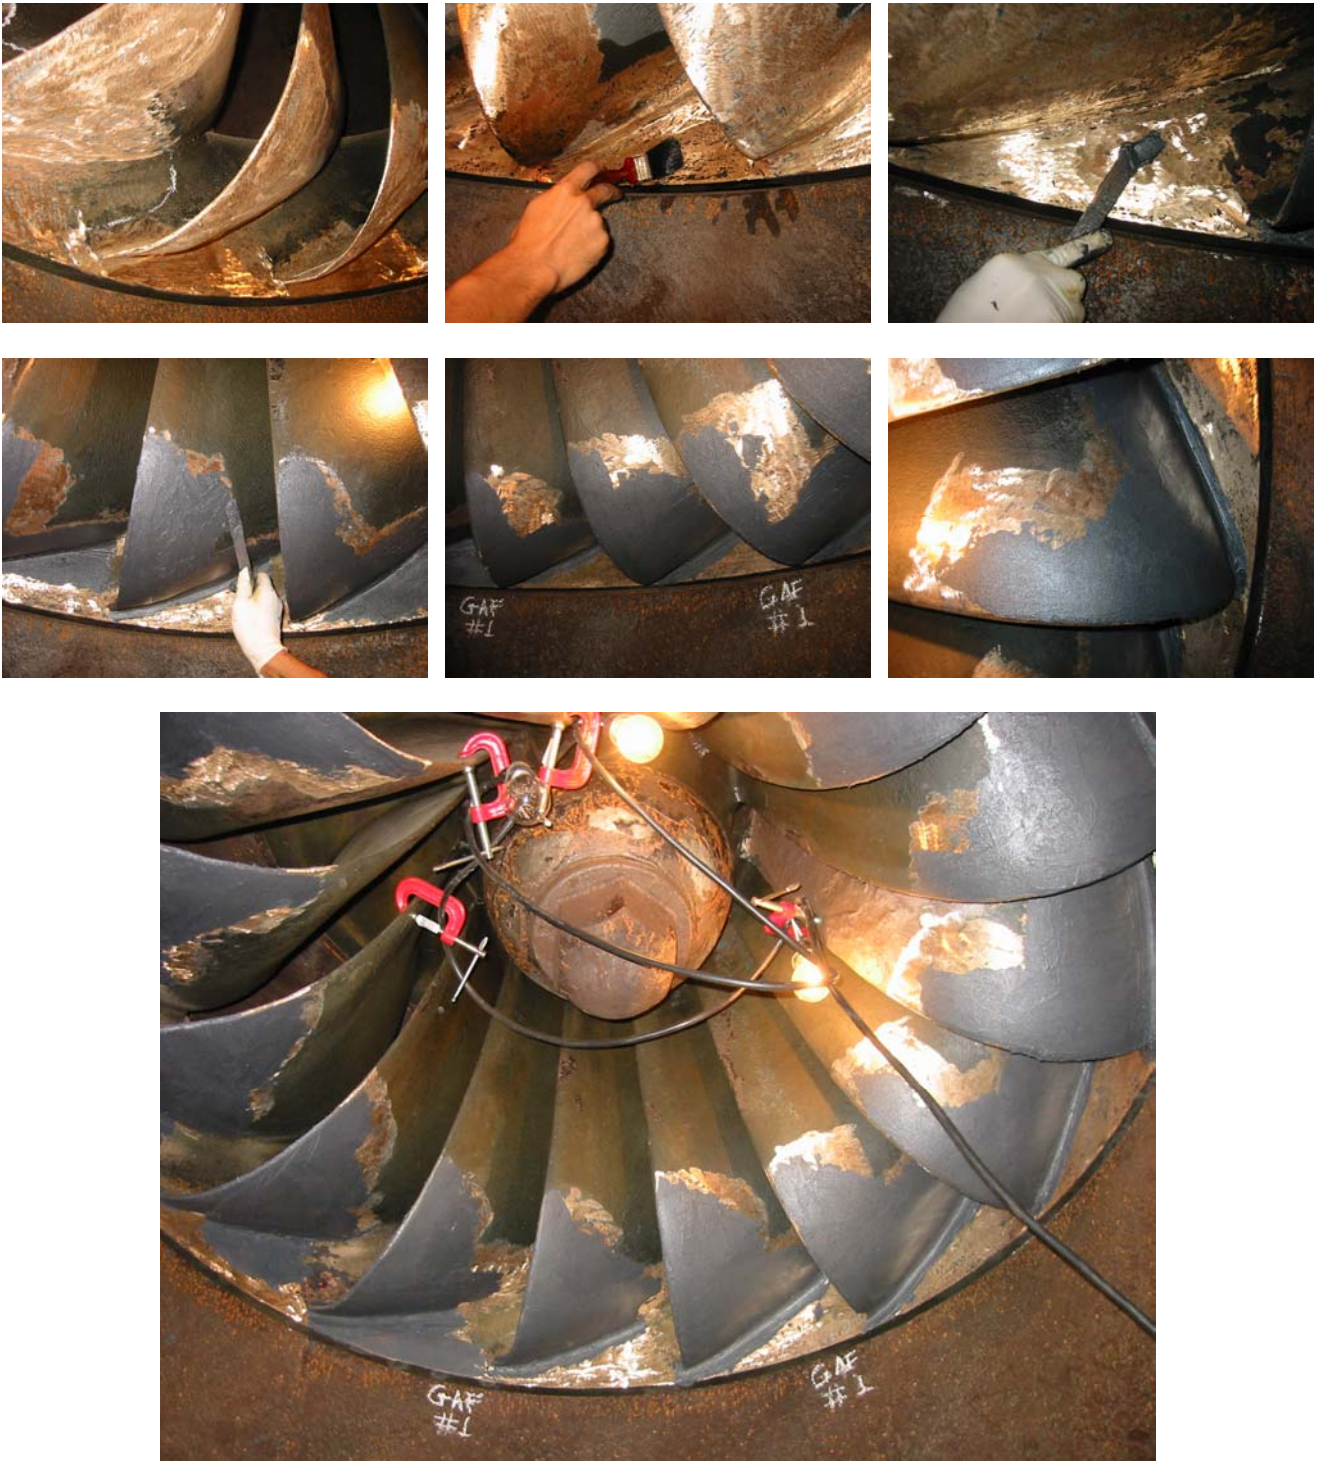
REP-#144

A turbine paddle was worn out caused by a water-sand-mixture. The pasty variant of the PolymerMetal Ceramium was used to rebuild the worn-out areas.

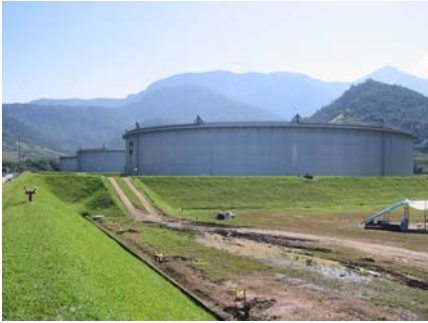
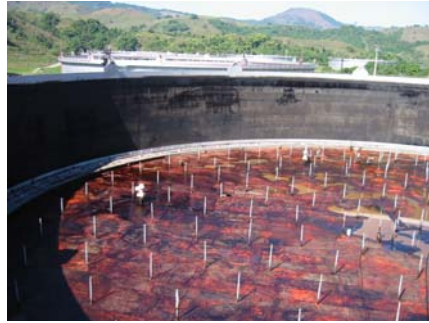
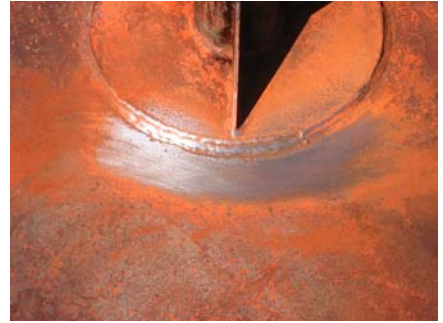
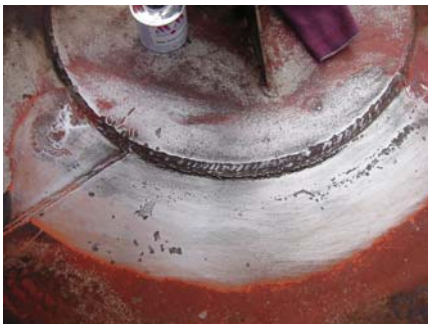
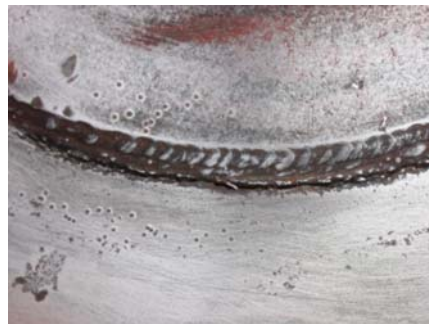
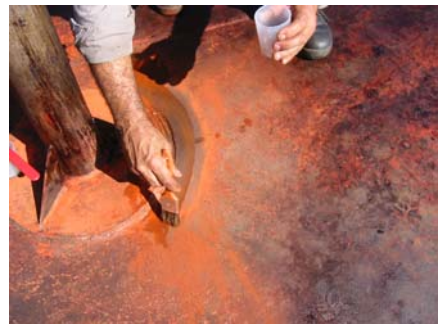
REP-#148

Several holes and damaged spots respectively in the roof of a big tank at an oil refinery were first grinded and cleaned to prepare the surface and then coated with Ceramium. Then the Ceramium was grinded to rough up the surface. Finally a layer of MM-Elastomer was applied to compensate any bigger tensions.

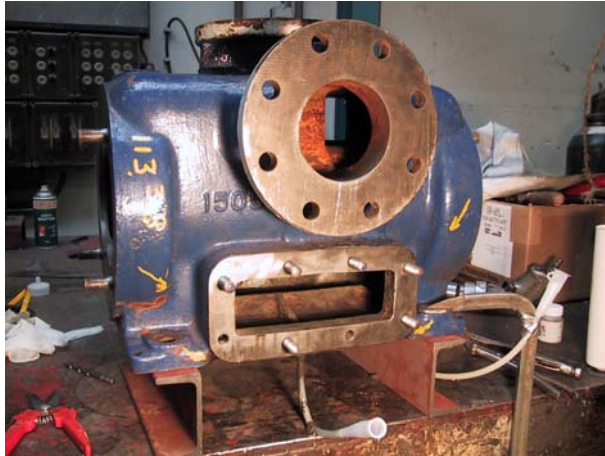
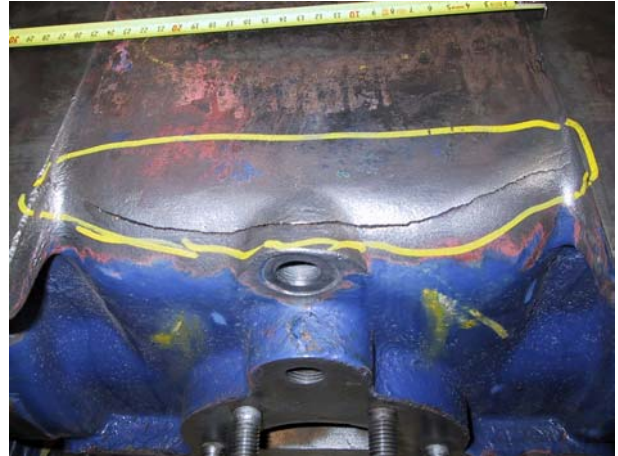
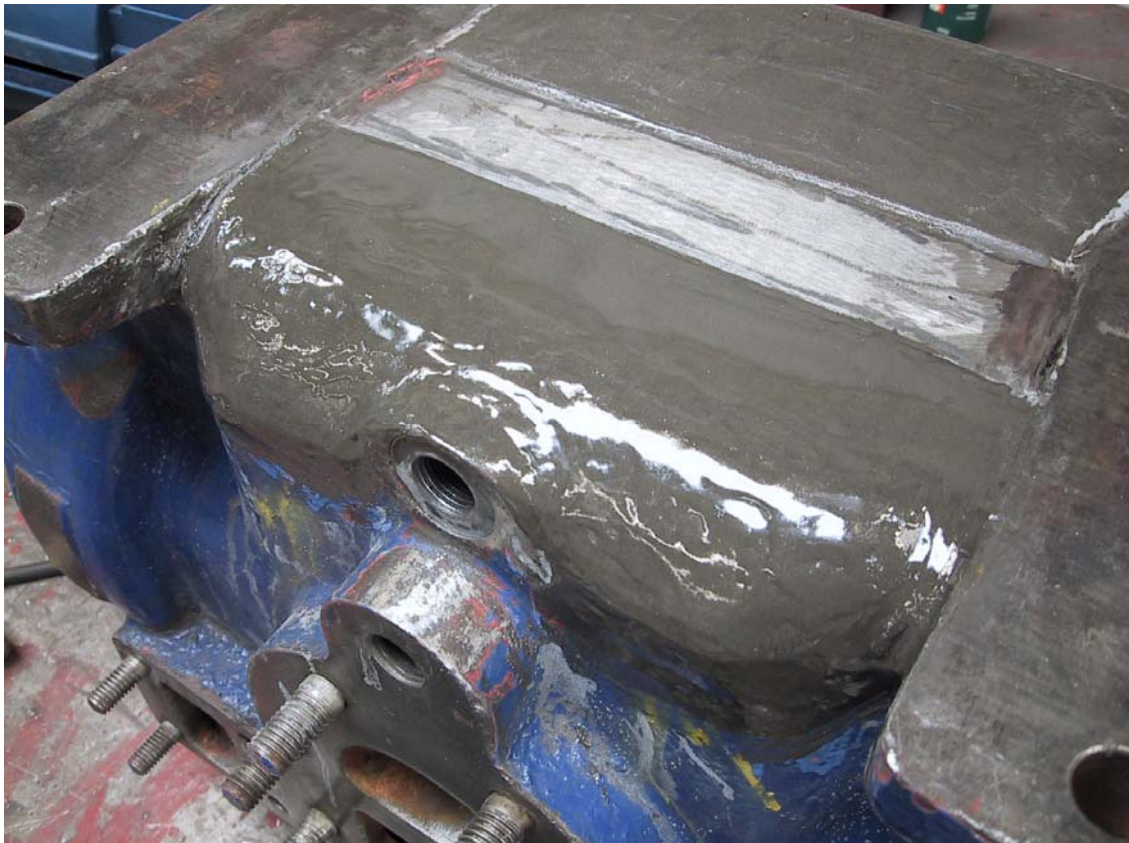
REP-#150

A broken pump casing was repaired with the help of the PolymerMetal MM-metal SS-steel.

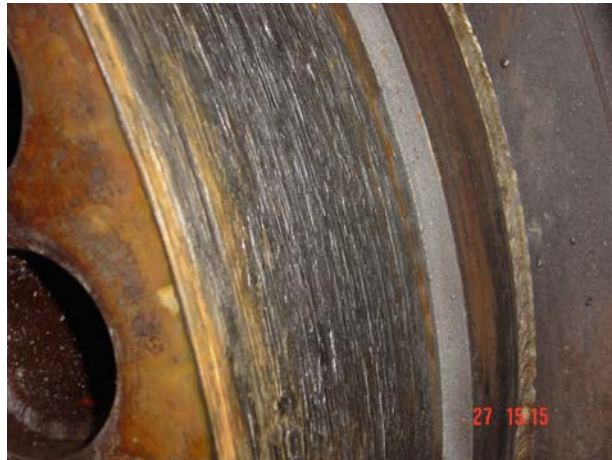
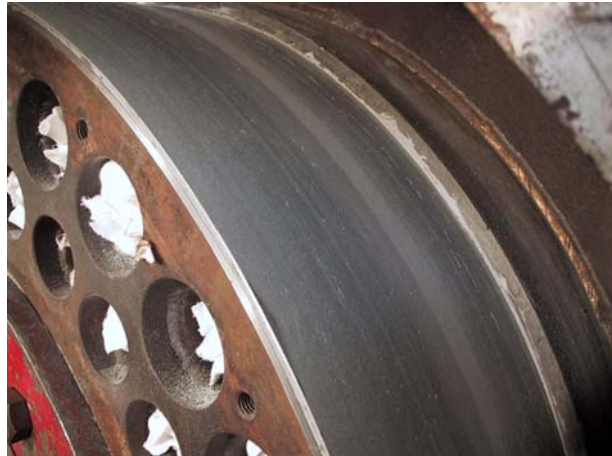
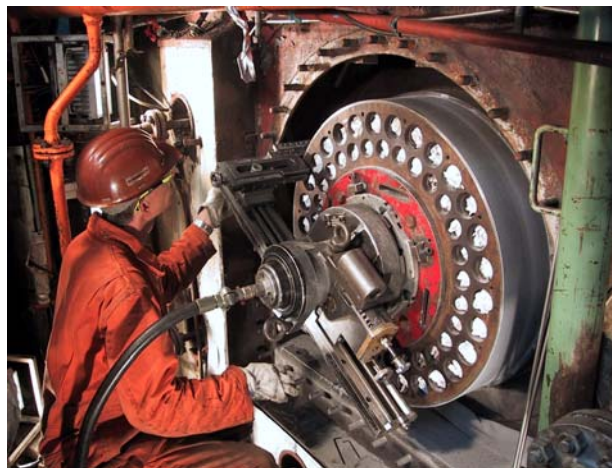
REP-#152

Onto a damaged area of an axle end MM-metal SS-steel, later MM-metal SS-steel 382 was applied to receive a higher surface quality. After curing, the work piece was machined down with a lathe to the desired diameter.

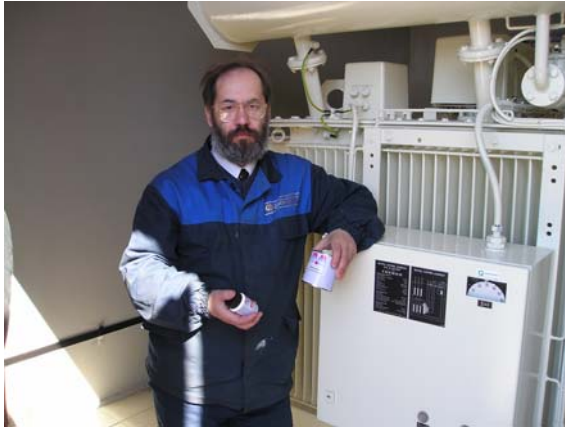
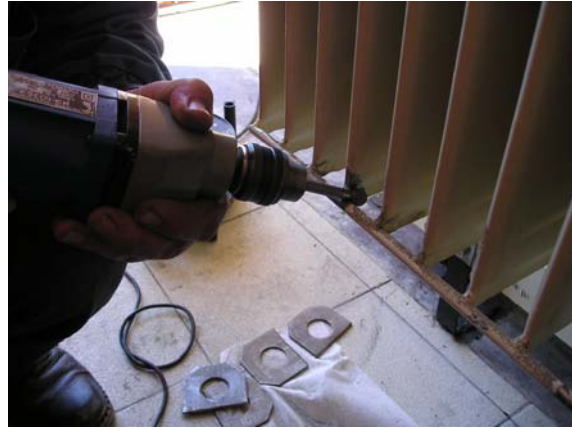
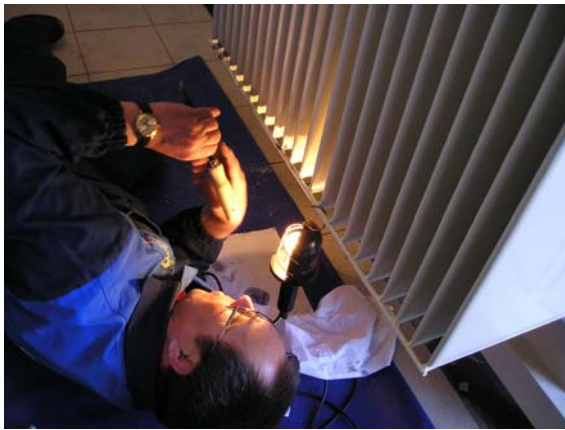
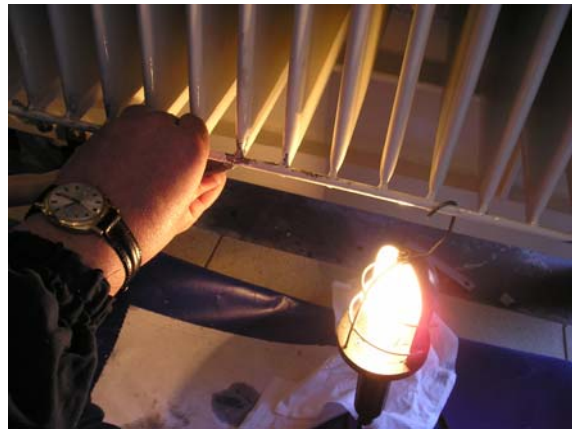
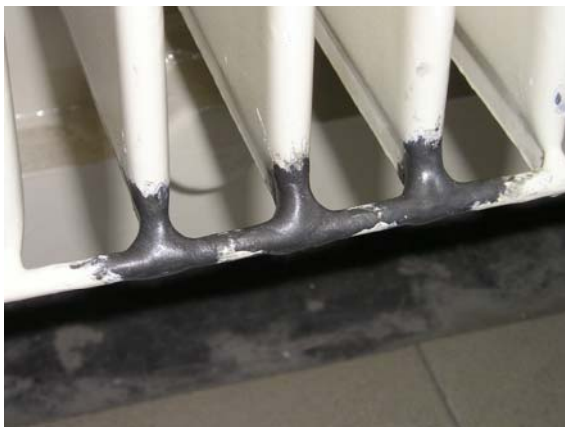
REP-#156

The welding at 19 places of transformers had micro cracks and blowholes, where oil exuded. First the paint has been removed with an electro drill equipped with an abrasive tool and the metal has been cleaned at the defective areas. Then MM-metal oL-steelceramic with Hardener red and afterwards Hardener yellow was applied. After checking the tightness of the repaired areas the corresponding areas have been painted over again.

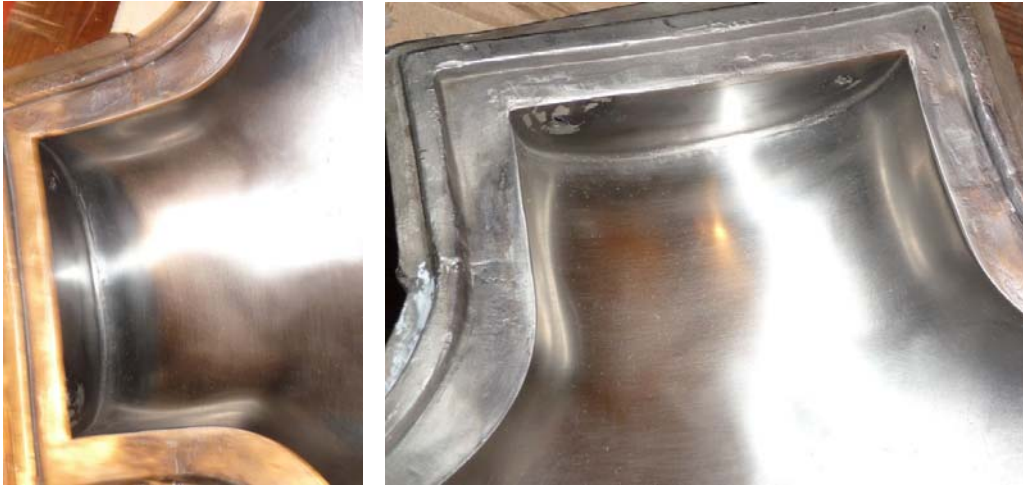
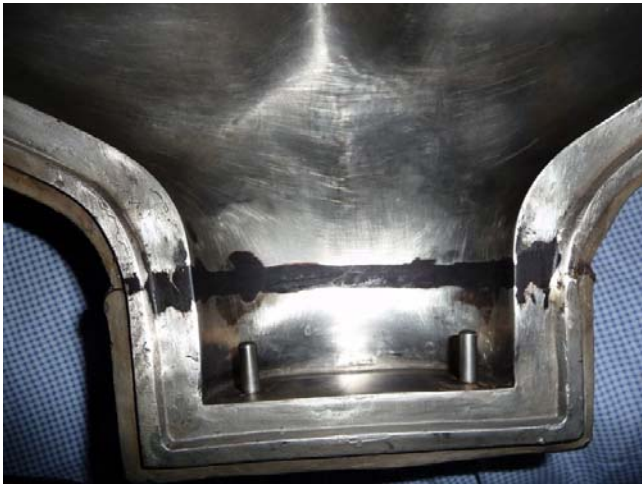
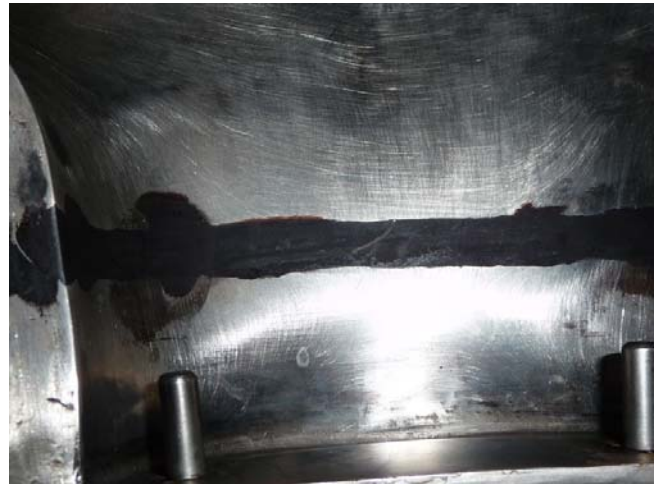
REP-# 163

A tool form of nickel for the torsos production of complex medical rubber dummies had to be adapted in the cervical region. The form was first cut in the cervical area. The attempt by soldering to join again the parts of the form being adjusted in the meantime, failed. Leakages by embedded air bubbles occurred in the cast parts in the area of the seam. By the alternative application of Ceramium BD the form could be put into operation again successfully. The seam was grinded 2 mm deep, cleaned with acetone and warmed up in the stove on 100 °C. Then Ceramium BD was applied in the repair area. After sufficient curing of approx. 1 - 1,5 hours the form was grinded and covered with Sealium respectively immersed in Sealium. The result was a clean surface without noticeable passages in the seam. The form stood firm easily the working temperature of 265 °C.
